# Asbestos Pre-Demolition Survey Report

Job Ref No: **18280**, Account Ref No: **71**, Contract Ref No: **1530**

## Former Grove Park Girls Grammar School Penmaes Avenue Wrexham LL12

*Including: Phase 2*

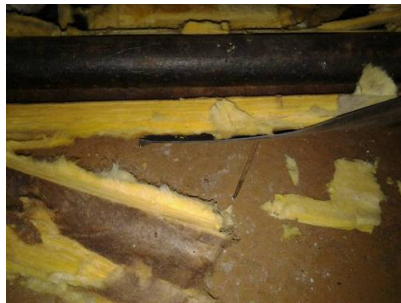
Building	Level	Location	Item / Product Examined	Sample No.	Material Description	Fibre Type	Material Score	Extent	Risk Level Assessment	Initial Control Recommendation	Photograph
Grove Park - Girls Grammar School	-1	001/ service duct	residues to pipes	18280-51	Asbestos-containing insulation	Chrysotile	10	Extent Undiscernable	R1	Remove

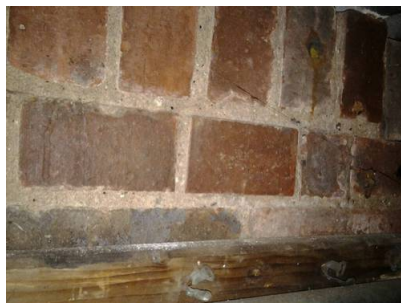
Grove Park - Girls Grammar School	-1	001/ service duct	debris to walls	18280-50	Asbestos-containing insulation	Crocidolite, Amosite, Chrysotile	12	Throughout Location	R1	Remove

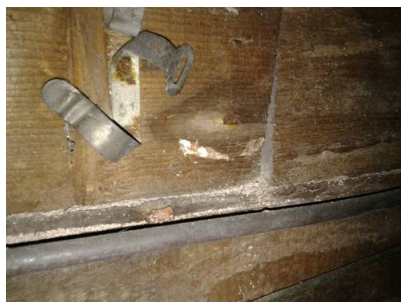
Grove Park - Girls Grammar School	-1	001/ service duct	debris to wall	18280-50	Asbestos-containing insulation	Crocidolite, Amosite, Chrysotile	12	Small Quantity Observed	R1	Remove

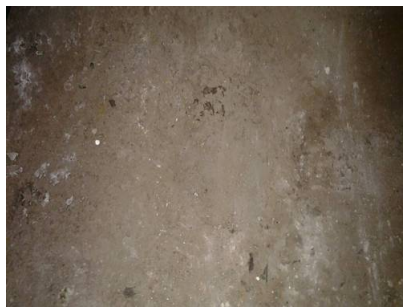
Building	Level	Location	Item / Product Examined	Sample No.	Material Description	Fibre Type	Material Score	Extent	Risk Level Assessment	Initial Control Recommendation	Photograph
Grove Park - Girls Grammar School	-1	001/ service duct	general debris to floor	18280-55	Asbestos-containing general non-specific dust/ debris to floor	Crocidolite, Chrysotile	12	Extent Indiscernable	R1	Environmental Clean

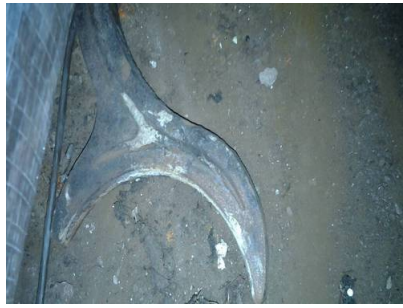
Grove Park - Girls Grammar School	-1	001/ service duct	debris to redundant brackets	18280-57	Asbestos-containing insulation	Crocidolite, Chrysotile	12	~4 No.	R1	Remove

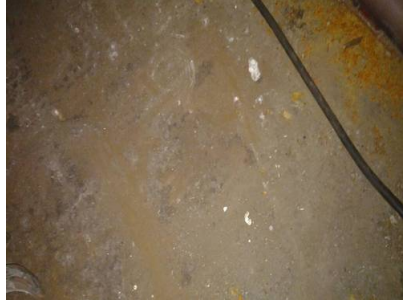
Grove Park - Girls Grammar School	-1	001/ service duct	general debris to floor	18280-56	Asbestos-containing general non-specific dust/ debris to floor	Chrysotile, Crocidolite	12	Extent Indiscernable	R1	Environmental Clean

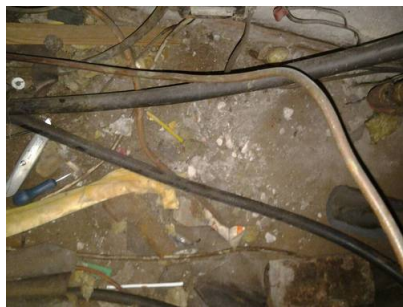
Building	Level	Location	Item / Product Examined	Sample No.	Material Description	Fibre Type	Material Score	Extent	Risk Level Assessment	Initial Control Recommendation	Photograph
Grove Park - Girls Grammar School	-1	001/ service duct	general debris to floor	18280-49	Asbestos-containing debris	Amosite, Chrysotile	8	Throughout Location	R2	Remove

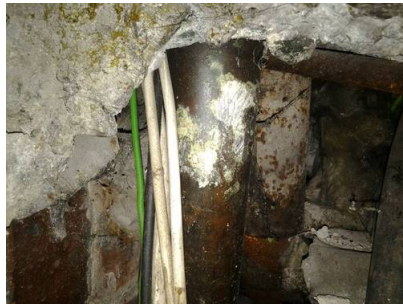
Grove Park - Girls Grammar School	-1	001/ service duct	residues to pipes	18280-48	Asbestos-containing insulation	Amosite, Chrysotile	11	Small Quantity Observed	R1	Remove

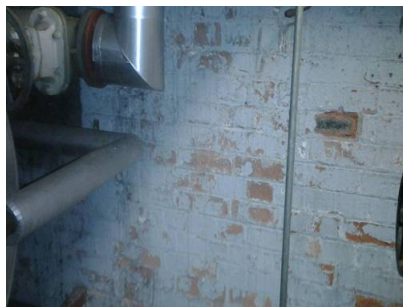
Building	Level	Location	Item / Product Examined	Sample No.	Material Description	Fibre Type	Material Score	Extent	Risk Level Assessment	Initial Control Recommendation	Photograph
Grove Park - Girls Grammar School	-1	002/ boiler room	debris to walls	18280-52	Asbestos-containing insulation	Crocidolite, Amosite, Chrysotile	12	Throughout Location	R1	Remove

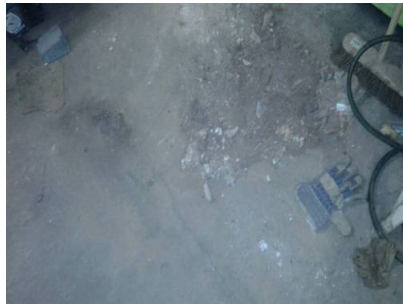
Grove Park - Girls Grammar School	-1	002/ boiler room	debris to floor	18280-53	Asbestos-containing insulation	Chrysotile	10	Throughout Location	R1	Remove

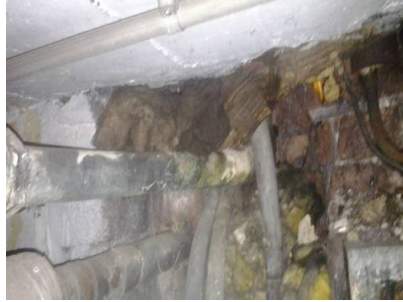
Grove Park - Girls Grammar School	-1	002/ boiler room	debris to pipework	18280-54	Asbestos-containing insulation	Amosite, Chrysotile	11	Throughout Location	R1	Remove

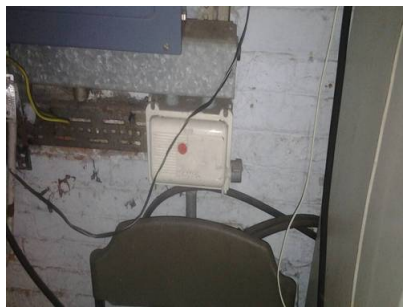
Building	Level	Location	Item / Product Examined	Sample No.	Material Description	Fibre Type	Material Score	Extent	Risk Level Assessment	Initial Control Recommendation	Photograph
Grove Park - Girls Grammar School	-1	002/ boiler room	within electrical switch gear		Asbestos-containing woven product	Presume Chrysotile			PRESUME

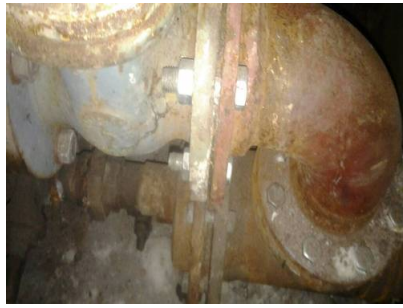
Grove Park - Girls Grammar School	-1	002/ boiler room	gaskets to pipework	18280-63	Asbestos-containing gasket	Chrysotile	5	~30 No.	R3	Remove

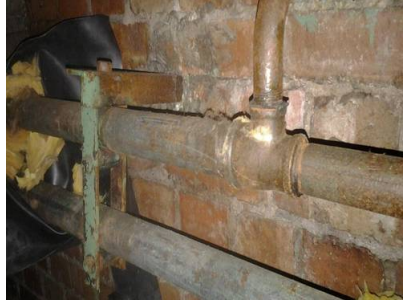
Grove Park - Girls Grammar School	-1	003/ undercroft	debris to pipework	18280-60	Asbestos-containing debris	Chrysotile	10		R1	Remove

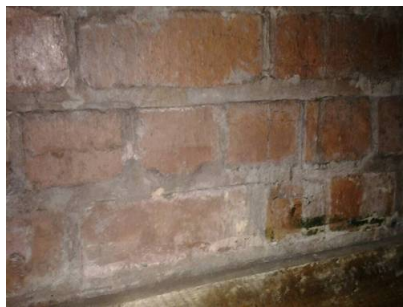
Building	Level	Location	Item / Product Examined	Sample No.	Material Description	Fibre Type	Material Score	Extent	Risk Level Assessment	Initial Control Recommendation	Photograph
Grove Park - Girls Grammar School	-1	003/ undercroft	debris to wall	18280-61	Asbestos-containing debris	Chrysotile	10	Throughout Location	R1	Remove

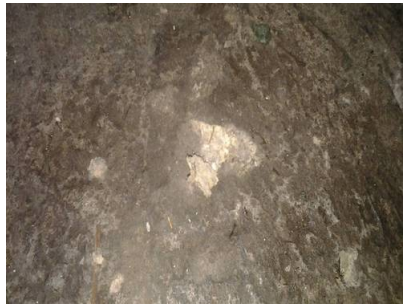
Grove Park - Girls Grammar School	-1	004/ undercroft	debris to floor	18280-67	Asbestos-containing insulation	Crocidolite, Chrysotile	12	Throughout Location	R1	Remove

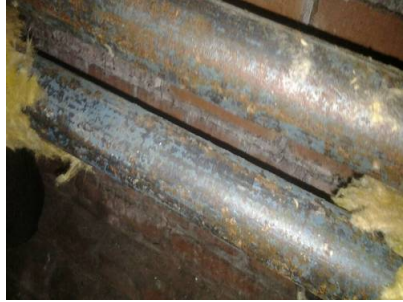
Grove Park - Girls Grammar School	-1	004/ undercroft	debris to pipework	18280-68	Asbestos-containing insulation	Crocidolite, Chrysotile	12	Extent Indiscernable	R1	Remove

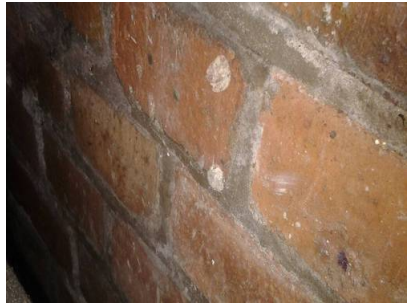
Building	Level	Location	Item / Product Examined	Sample No.	Material Description	Fibre Type	Material Score	Extent	Risk Level Assessment	Initial Control Recommendation	Photograph
Grove Park - Girls Grammar School	-1	004/ undercroft	debris to walls	18280-66	Asbestos-containing insulation	Crocidolite, Chrysotile	12	Throughout Location	R1	Remove

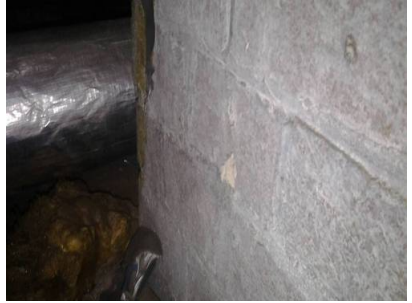
Grove Park - Girls Grammar School	-1	004/ undercroft	debris to walls to duct entrance	18280-65	Asbestos-containing insulation	Crocidolite, Chrysotile	12	Extent Indiscernable	R1	Remove

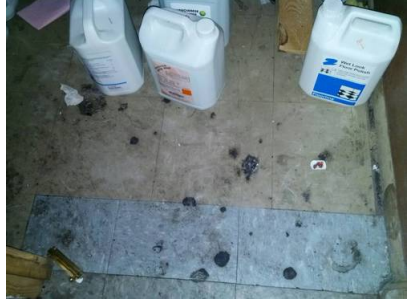
Grove Park - Girls Grammar School	0	002/ store	floor covering	18280-5	Asbestos-containing vinyl tile	Chrysotile	3	2 Sqm.	R3	Remove

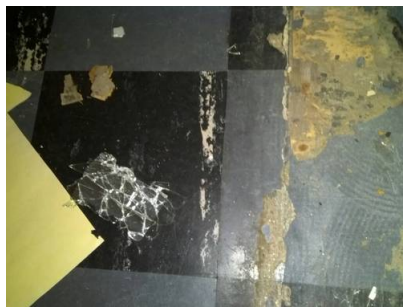
Building	Level	Location	Item / Product Examined	Sample No.	Material Description	Fibre Type	Material Score	Extent	Risk Level Assessment	Initial Control Recommendation	Photograph
Grove Park - Girls Grammar School	0	006/ classroom	floor covering	18280-6	Asbestos-containing vinyl tile	Chrysotile	3	15 Sqm.	R3	Remove

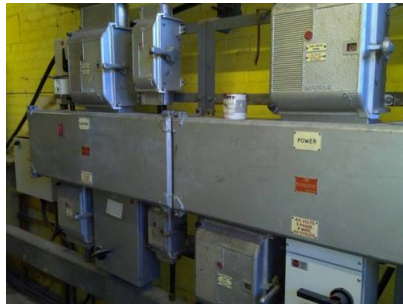
Grove Park - Girls Grammar School	0	007/ electrical room	electrics		Asbestos-containing woven product	Presume Chrysotile			PRESUME

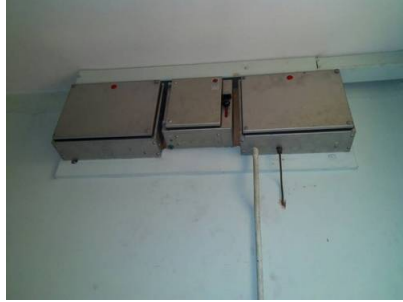
Grove Park - Girls Grammar School	0	014/ store	electrics		Asbestos-containing woven product	Presume Chrysotile			PRESUME

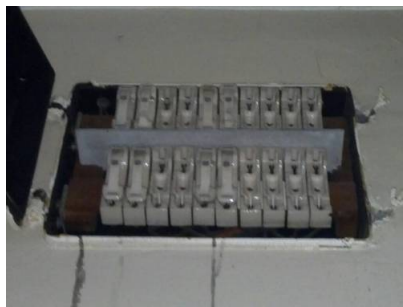
Building	Level	Location	Item / Product Examined	Sample No.	Material Description	Fibre Type	Material Score	Extent	Risk Level Assessment	Initial Control Recommendation	Photograph
Grove Park - Girls Grammar School	0	025/ staff room	electrics	18280-18	Asbestos-containing insulation board	Chrysotile	5	2 No.	R3	Remove

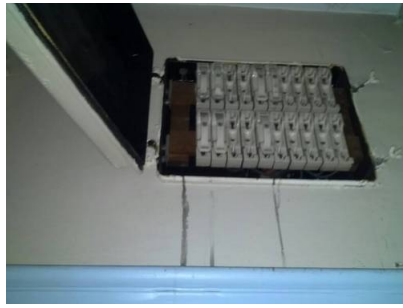
Grove Park - Girls Grammar School	0	025/ staff room	insulation to fuse	18280-19	Asbestos-containing paper	Chrysotile	6	8 No.	R2	Remove

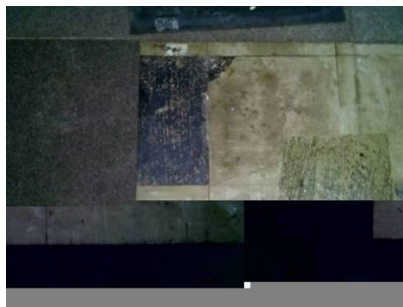
Building	Level	Location	Item / Product Examined	Sample No.	Material Description	Fibre Type	Material Score	Extent	Risk Level Assessment	Initial Control Recommendation	Photograph
Grove Park - Girls Grammar School	0	051/ classroom	subfloor	18280-35	Asbestos-containing vinyl tile	Chrysotile	3	12 Sqm.	R3	Remove

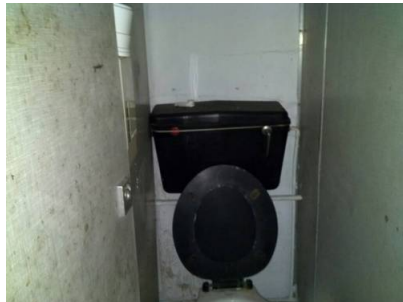
Grove Park - Girls Grammar School	0	054/ w.c.	toilet cistern	18280-36	Asbestos-containing composite	Amosite	4	4 No.	R3	Remove

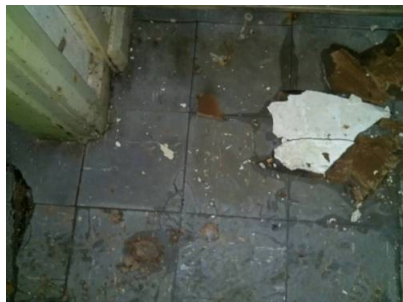
Grove Park - Girls Grammar School	0	055/ store	floor covering	18280-38	Asbestos-containing vinyl tile	Chrysotile	3	3 Sqm.	R3	Remove

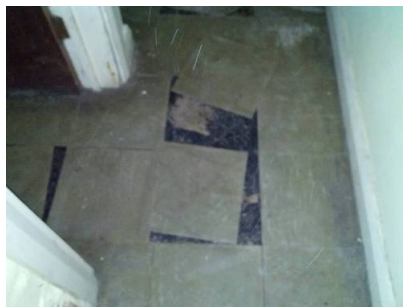
Building	Level	Location	Item / Product Examined	Sample No.	Material Description	Fibre Type	Material Score	Extent	Risk Level Assessment	Initial Control Recommendation	Photograph
Grove Park - Girls Grammar School	0	057/ w.c.	floor covering	18280-39	Asbestos-containing vinyl tile	Chrysotile	3	4 Sqm.	R3	Remove

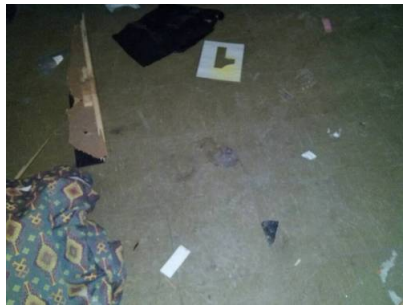
Grove Park - Girls Grammar School	0	058/ w.c.	floor covering	18280-39	Asbestos-containing vinyl tile	Chrysotile	3	4 Sqm.	R3	Remove	
Grove Park - Girls Grammar School	0	059/ staff room	floor covering	18280-39	Asbestos-containing vinyl tile	Chrysotile	3	4 Sqm.	R3	Remove	
Grove Park - Girls Grammar School	0	060/ store	floor covering	18280-39	Asbestos-containing vinyl tile	Chrysotile	3	4 Sqm.	R3	Remove	
Grove Park - Girls Grammar School	0	061/ circ.	floor covering	18280-39	Asbestos-containing vinyl tile	Chrysotile	3	4 Sqm.	R3	Remove	
Grove Park - Girls Grammar School	0	062/ store	floor covering	18280-41	Asbestos-containing vinyl tile	Chrysotile	3	4 Sqm.	R3	Remove

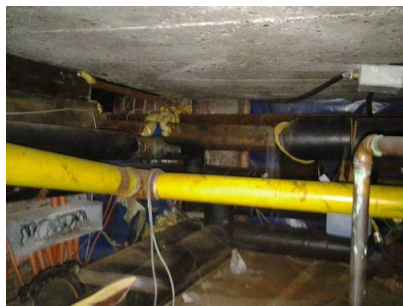
Building	Level	Location	Item / Product Examined	Accessibility	Surveyor Additional Comments At Time Of Survey	Photograph
Grove Park - Girls Grammar School	-1	001/ service duct	service duct	Limited Access	physically restricted space - floor requires breaking out or services removing in order to access duct - see plan for location

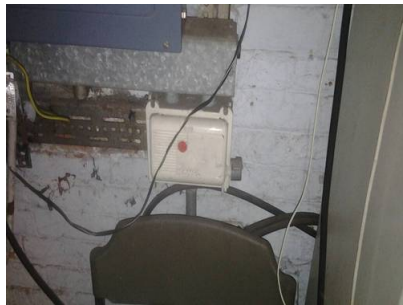
Grove Park - Girls Grammar School	-1	002/ boiler room	within electrical switch gear	Limited Access	live service supply

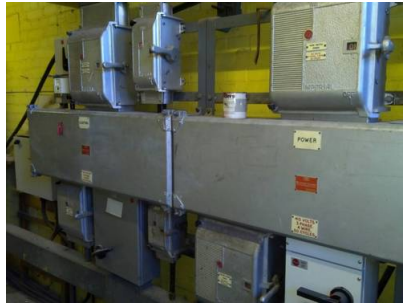
Grove Park - Girls Grammar School	0	007/ electrical room	electrics	Limited Access	live service supply

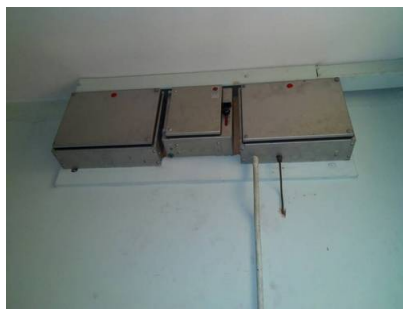
Building	Level	Location	Item / Product Examined	Accessibility	Surveyor Additional Comments At Time Of Survey	Photograph
Grove Park - Girls Grammar School	0	014/ store	electrics	Limited Access	live service supply

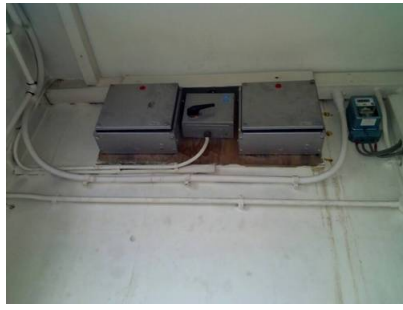
Grove Park - Girls Grammar School	0	029/ boiler room	electrics	Limited Access	live service supply

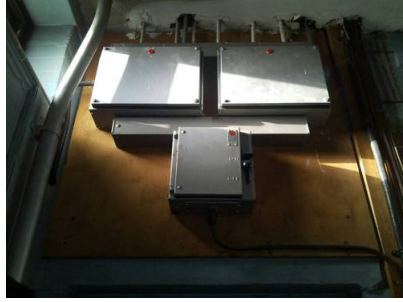
Grove Park - Girls Grammar School	1	007/ store room	electrics	Limited Access	live service supply
